# Boston's Open Space

1987  
PARK EVALUATION  
&  
SITE SUMMARIES

EVALUATION OF  
CITY OF BOSTON  
PARK AND RECREATION LAND

NEIGHBORHOOD OF HYDE PARK

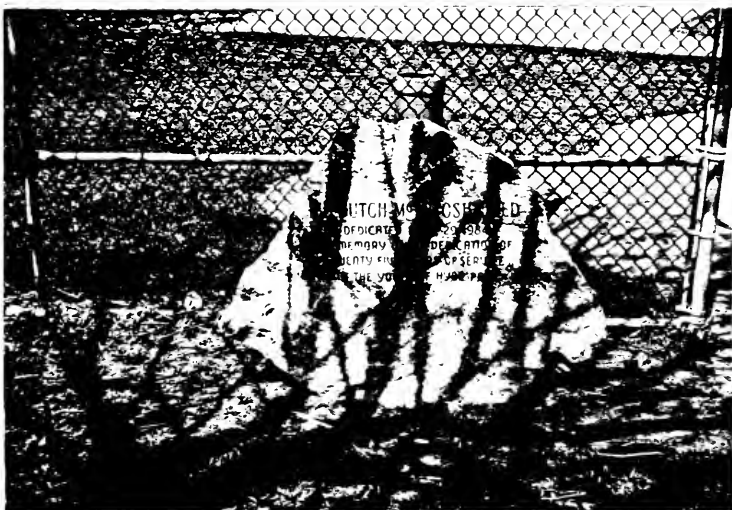
## Site Photograph 3

Memorial.

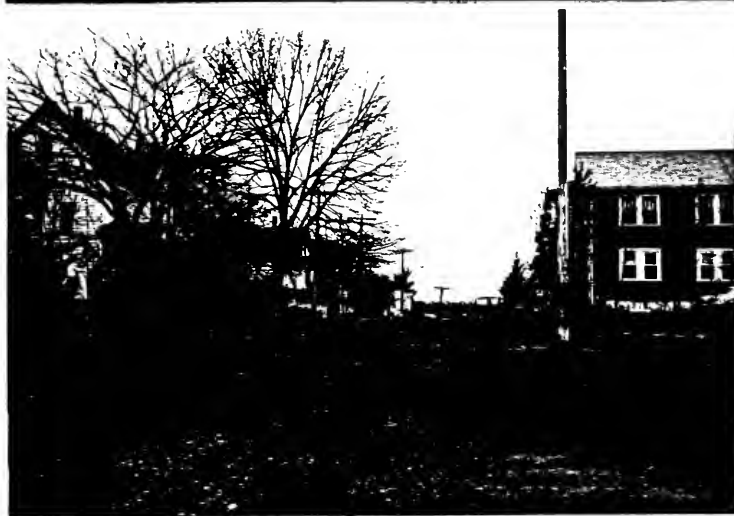
**Site Photograph 5**

Access from Rosa Street.

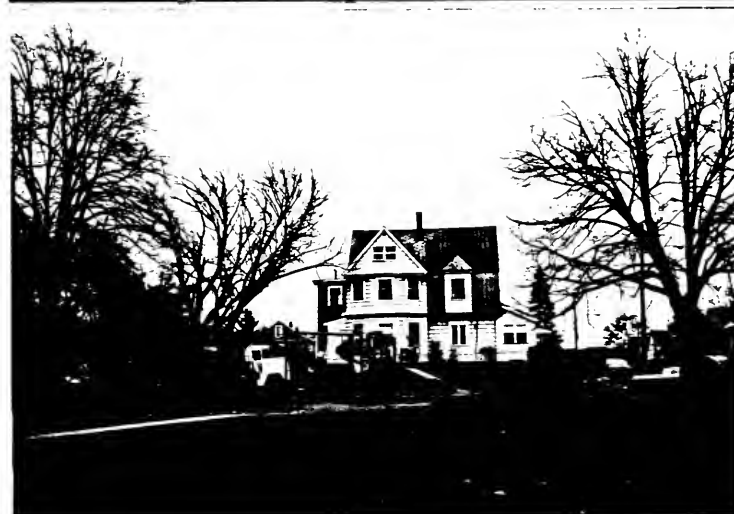
**Site Photograph 6**

New playground undergoing construction.

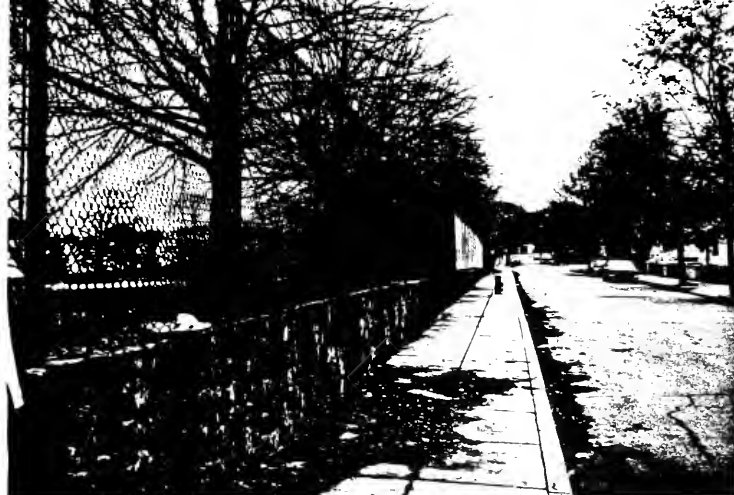
**Site Photograph 7**

Well-built stone wall  
with chain link fence.

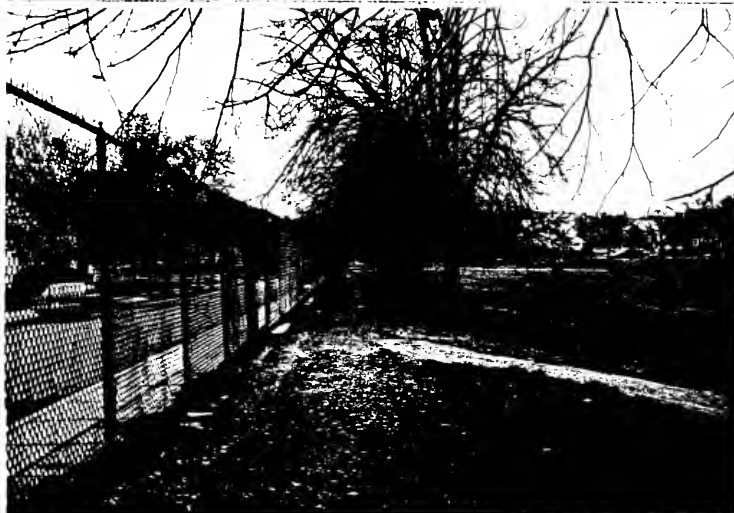
**Site Photograph 8**

Perimeter planting of  
Lindens a significant  
feature of site. Old  
asphalt walkway to  
left of trees.

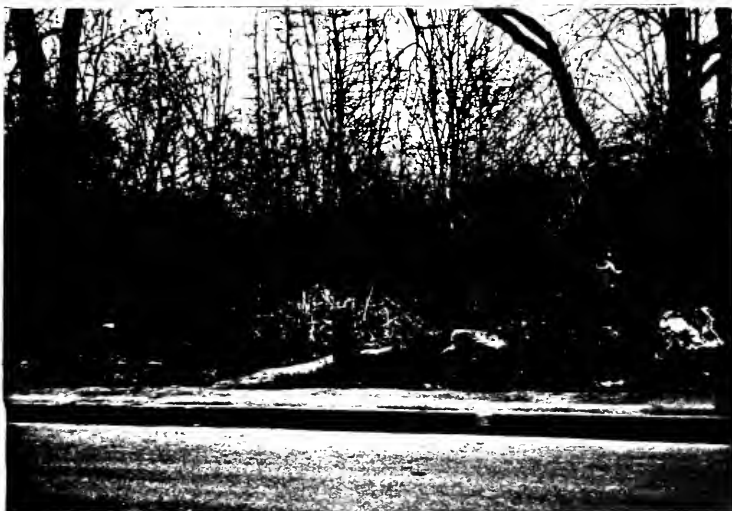
### Site Photograph 1

Entrance to park with  
urban wild to right.

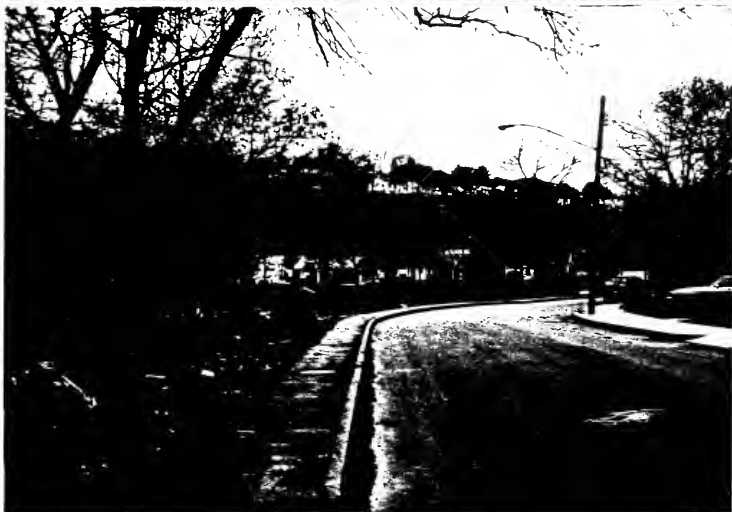
### Site Photograph 2

Shows location of  
park within residential  
neighborhood.

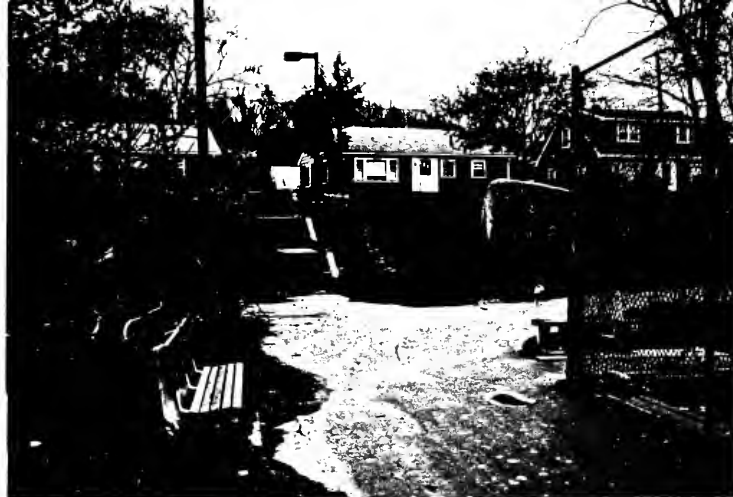
#### Site Photograph 4

Timber steps up to Sherrin Street. Urban wild to left.

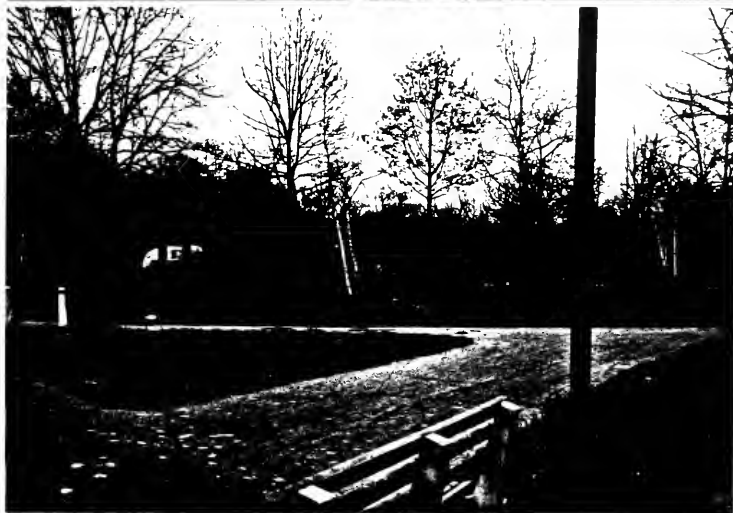
#### Site Photograph 5

View into picnic/play area showing original and planted trees.

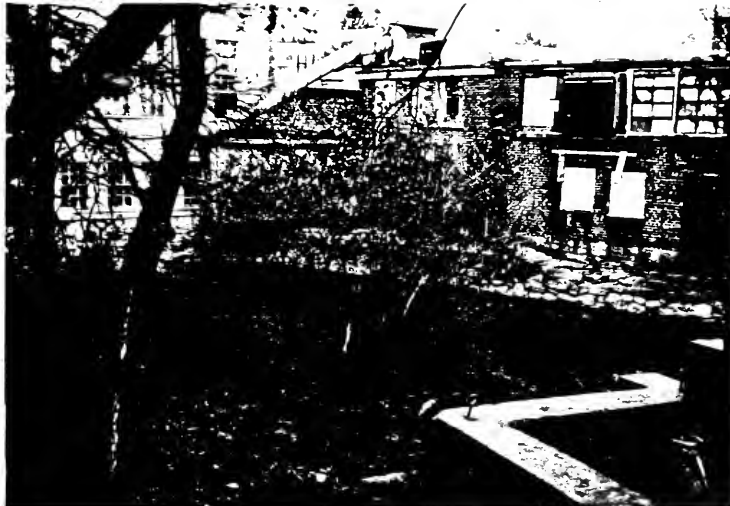
### Site Photograph 1

Industrial view from  
edge of Mother Brook.

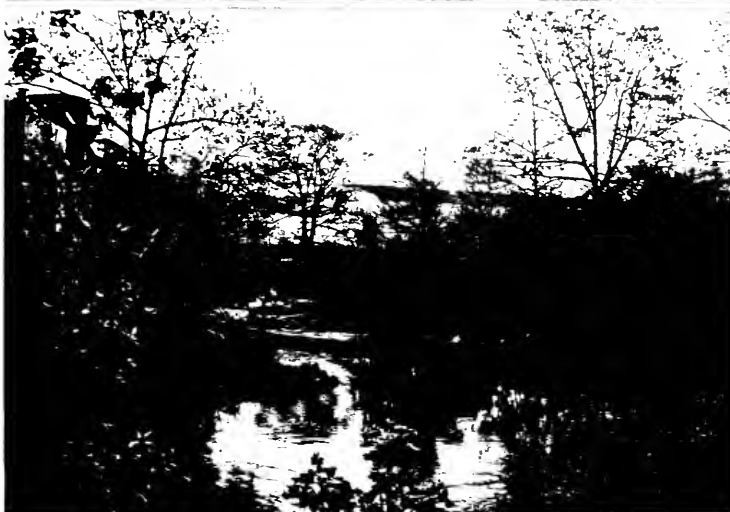
### Site Photograph 2

Scenic view of bend  
in the river.

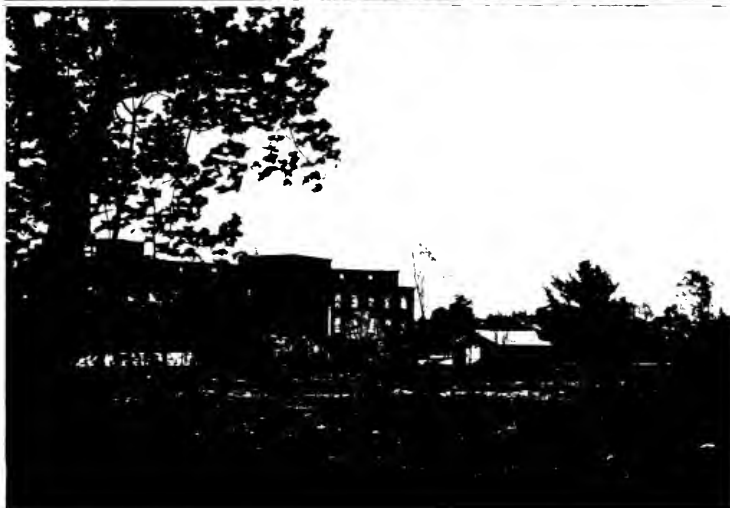
### Site Photograph 3

View looking east  
from site towards  
railroad tracks.

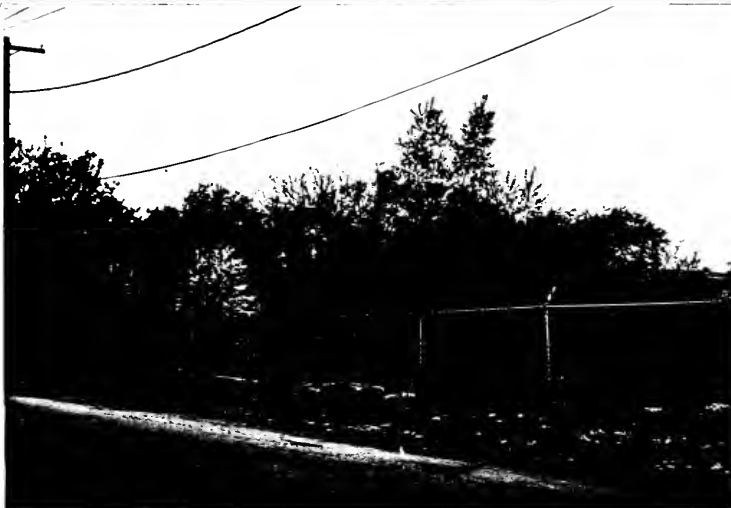
**Site Photograph 6**

View into Motherbrook II site from Reservation Road.

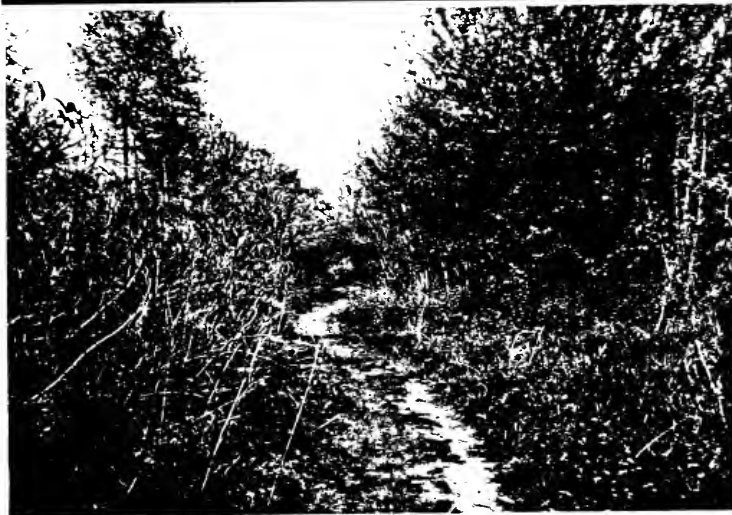
**Site Photograph 2**

Pathway along edge  
of railway. Crabapples  
thriving to right.

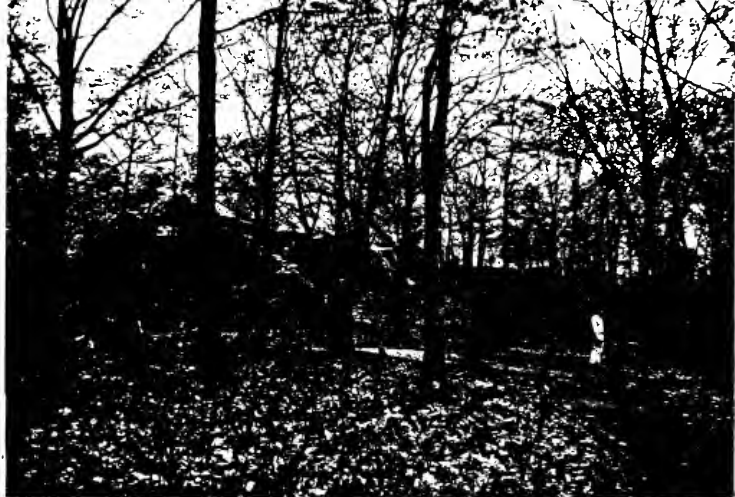
#### Site Photograph 4

Rock outcrop in center  
of site a focal point.

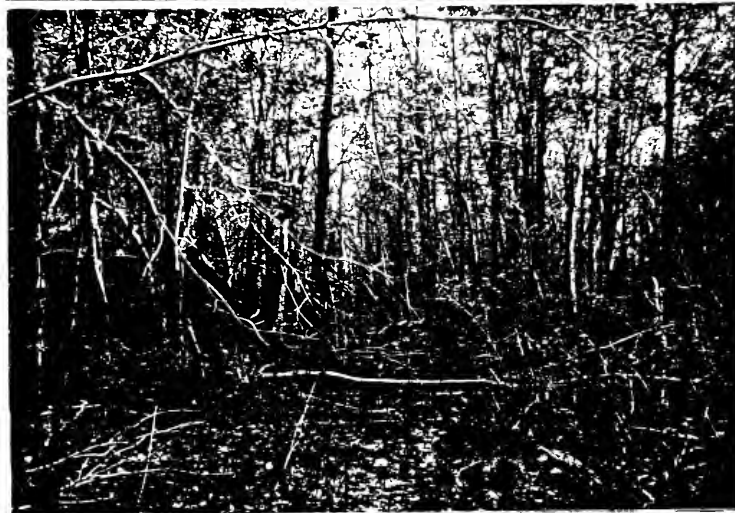
#### Site Photograph 5

Typical view looking  
into woods.

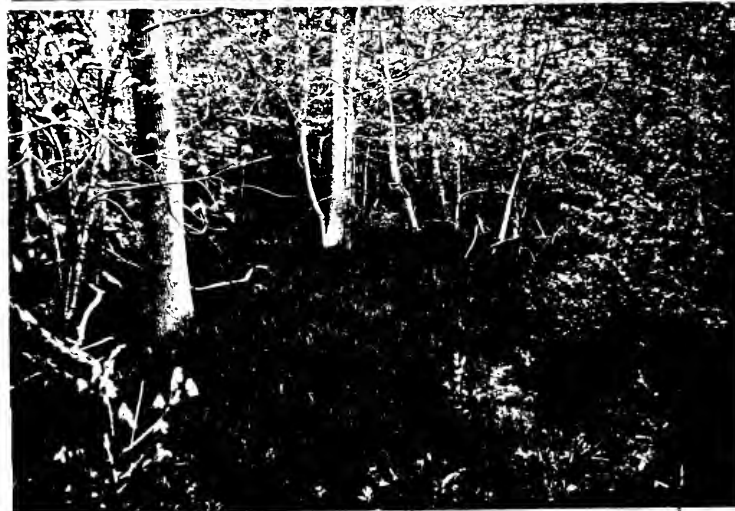
#### Site Photograph 6

Typical view looking  
into wetland.

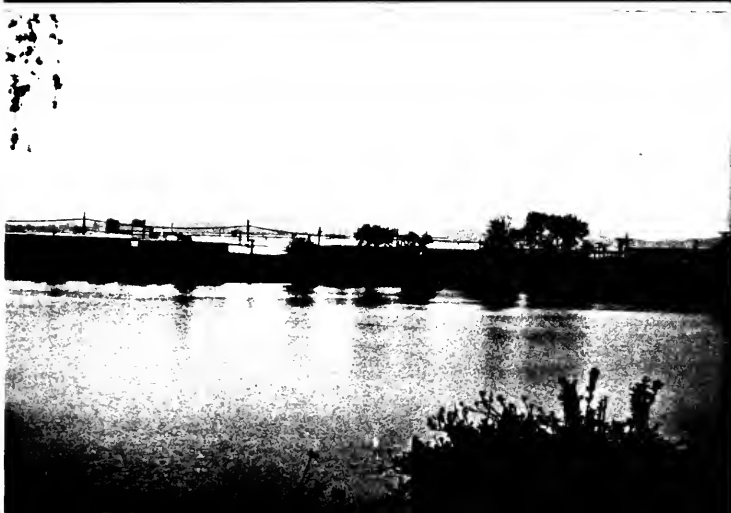
### **Site Photograph 3**

View across Sprague Pond with railway yard and Blue Hills in the distance.

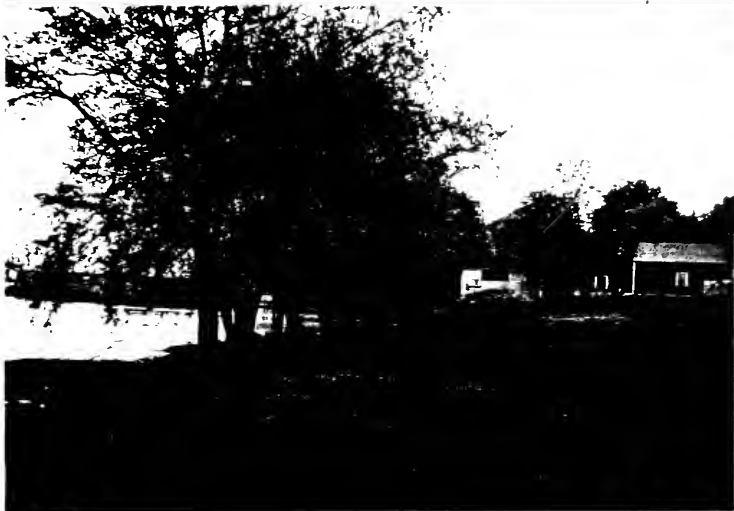
**Site Photograph 5**

Willow trees at water's edge.
